FURTHO DOVECOTE NORTHAMPTONSHIRE

BRIAN L GIGGINS 1994

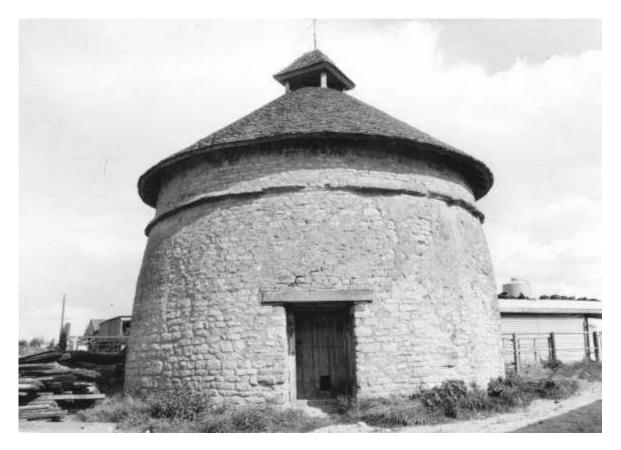
1. North-west elevation

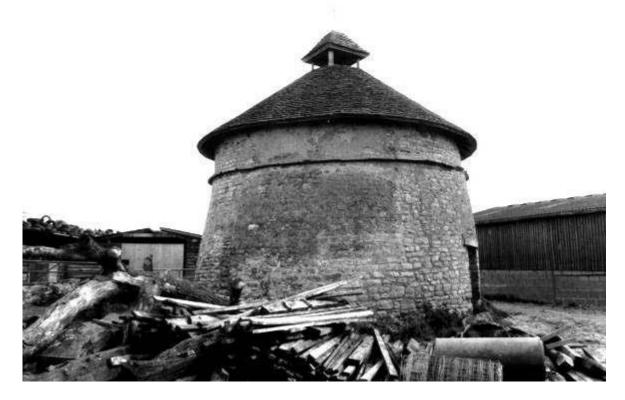
2. West elevation

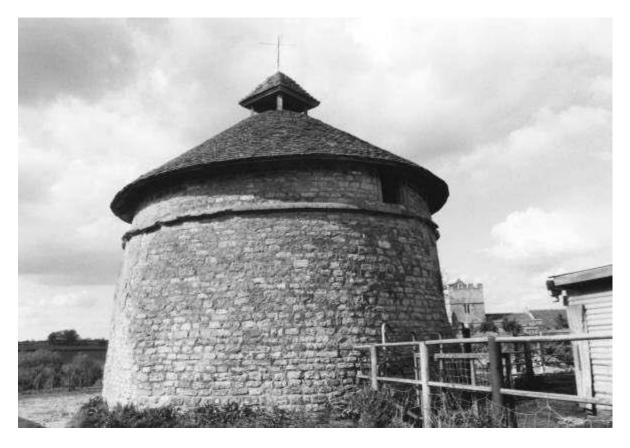
3 – South-west elevation

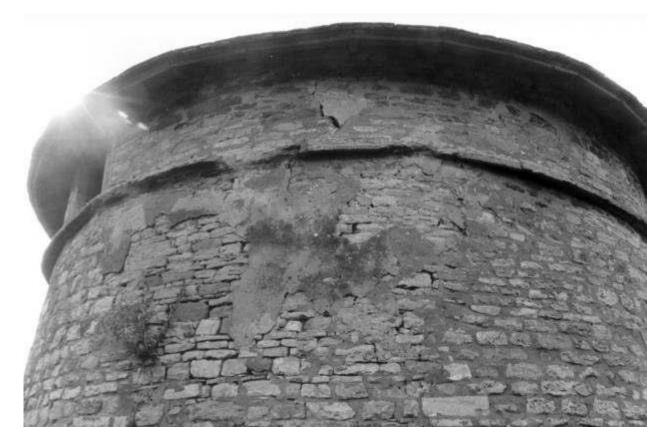
It is apparent that the walling has suffered considerably from settlement over the centuries which have caused movement, cracking and collapse. Parts of the east and south sides have been rebuilt and areas of stonework refaced, notably around the blocked south doorway.

4 – East elevation showing rendering

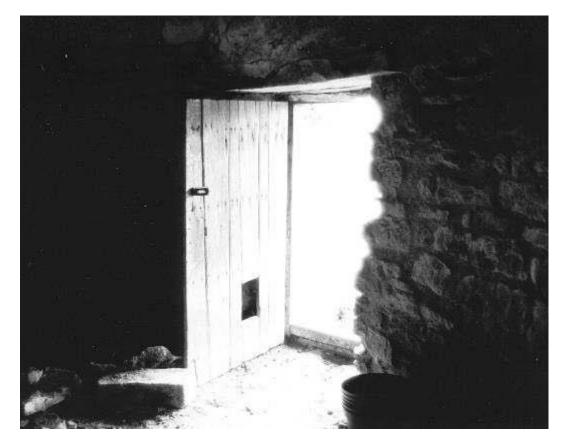
The opening for the north-west doorway is 1050mm wide by 1770mm high on the outside face and 860mm wide and 1580mm high on the inside face. Forming the roof of the opening are large timber lintels which are not laid level with each other and so form an irregular surface. The external lintel projects beyond the face of the wall and appears to be a recent replacement.

The door frame is constructed of 120mm x 100mm wide timbers and is set in 710mm from the front face. It forms an opening 1460mm high by 690mm wide. The plank door is 850mm x 1490mm and each plank has a roll moulding along one edge which is typical of the nineteenth century. A rectangular hole has been cut into the door to allow a cat access for vermin control.

5. North-west door

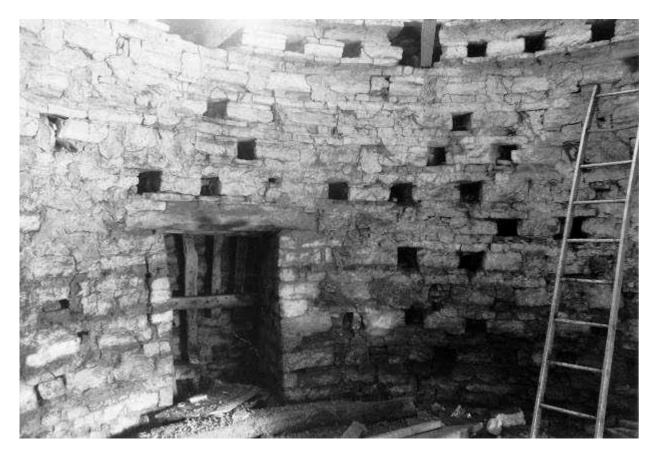
The south door has been blocked externally with stone and the original jambs are no longer visible. On the inside face the jambs survive to form an opening 820mm wide by 1370mm high. This opening is blocked after 600mm but in front of this blocking is a rough timber frame which appears to have been used to block off the entrance at an earlier phase. The timber lintel above the door is chamfered and stopped.

6. Blocked south-west door

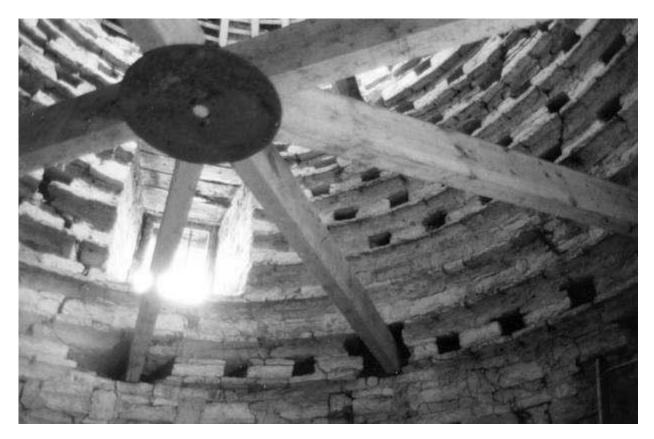
- 1980 circa Outbuilding to the east of the Old Manor House demolished
- 1987 Roof renewed under the directions of Merton College Surveyor.
- 1993 Tenant of farm inserts timber floor joists at approximately 3m above floor level to form the base of a floor for pigeons. This was without Scheduled Ancient Monument Consent.

7. Modern inserted floor timbers

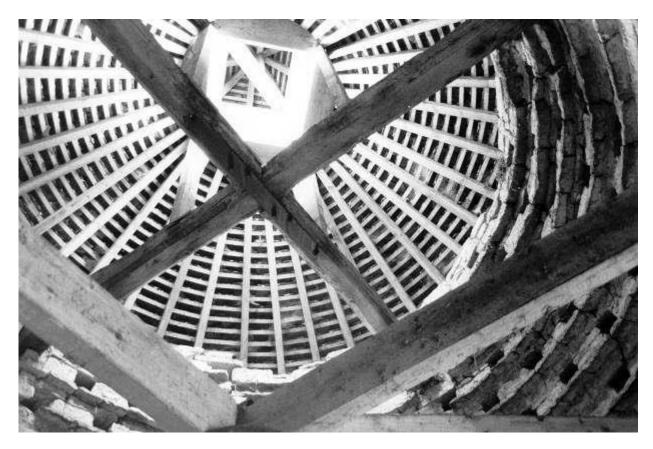
The tiled roof of the building was rebuilt in 1987 for the Trustees of the Edward Arnold Charity. At that time the majority of the roof timbers were replaced and the cross-beams repaired.

The cross-beams are constructed of 200mm square timbers with one timber spanning the interior and the other two timbers mortised into it. The undersides of the timbers have narrow chamfers with stops close to the wall and the centre. The undersides of the timbers are approximately 850mm below the top of the wall. The cross-timbers support four upright timbers which support the ring-beam at the base of the glover and continue up to form the posts of the lantern. Twenty common-rafters approximately 75mm square run radially from the ring-beam to the eaves where they overhang the walls by approximately 500mm. The ends of the rafters are rounded on the underside.

8 – Roof structure & glover

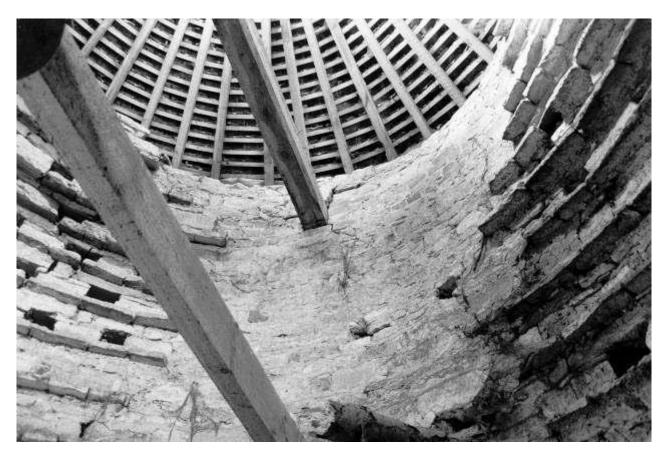
9 - Internal view showing rebuilt walling

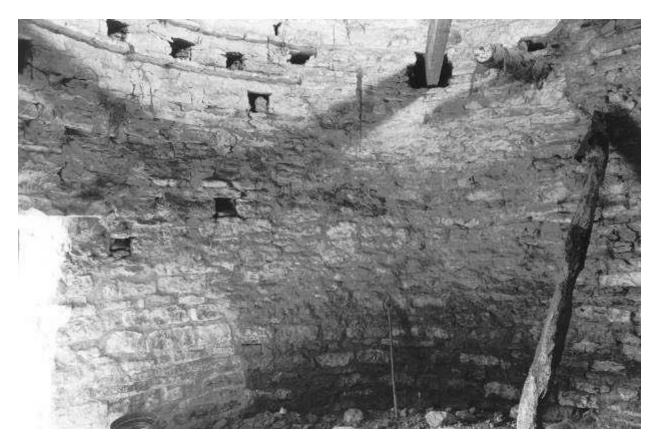
There are the remains of twenty rows of nesting boxes starting immediately above ground level and finishing just below the top of the wall. At its maximum diameter the walls could house thirty nesting boxes on each row which would suggest that the dovecote contained approximately 550 nesting boxes when first built. This would have been the number expected from a circular dovecote of this size. Today only about half of these nesting boxes survive. Some were lost when the walling on the north side was rebuilt and many in the lower 11 courses have been blocked in.

10. Internal view showing blocked nesting boxes

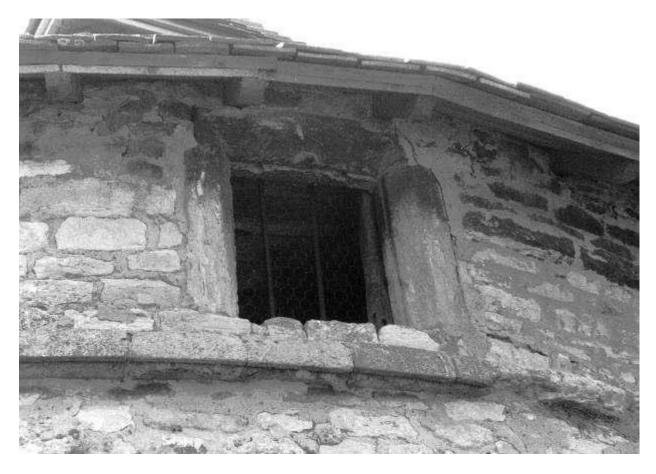
Above the blocked south door is a small stone mullioned window. This was situated immediately above the string course but was not accessible to be measured. It formed an opening approximately 500mm wide with stone flat splay moulded jambs. There was evidence for a central stone mullion of flat splayed mouldings on the head stone and it was apparent that the two openings were formerly glazed. The sides of the window opening are splayed and 930mm apart on the internal face. A wooden frame covered with wire mesh has been erected behind the window opening to keep out the birds. Flat splayed mullioned windows with square heads occur from the mid-sixteenth through to the mid-eighteenth centuries. The use of glazing in such a situation would be unlikely before 1600 and it is doubtful whether the window opening would be earlier.

11. Stone mullioned window

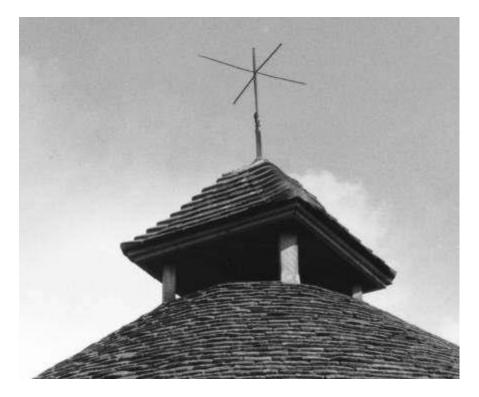
The glover has a circular opening and is surmounted by a lantern of four posts supporting a four sided pyramidal roof of tiles. Although this was reconstructed in 1987 there is a lantern of similar design illustrated on an eighteenth century drawing of the dovecote.

12. Lantern

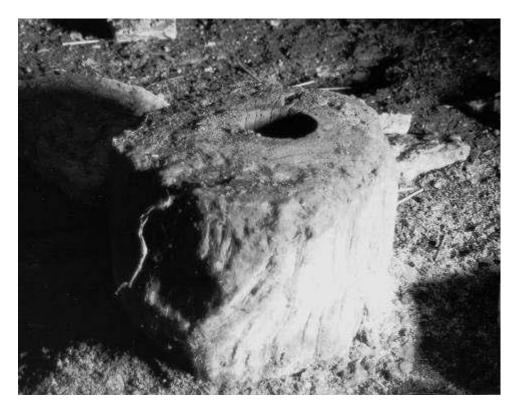
The only evidence for a potence is a large section of tree trunk approximately 560mm x 455mm which is set centrally into the earth floor and has a round hole cut into it which is 155mm in diameter and 83mm deep. At the base of the hole was a dark substance in which appeared to be a piece of broken brick or pottery.

It is tempting to interpret this as the base for the shaft of a potence but the top face of the timber is at an angle which would jar on a turning timber and shows no signs of wear. On the inside face of the round mortise are a few horizontal striations but these are insufficient to show regular turning within the mortise took place. If this is a potence base then it is of a primitive form as metal bearings would be expected.

13. Central timber block

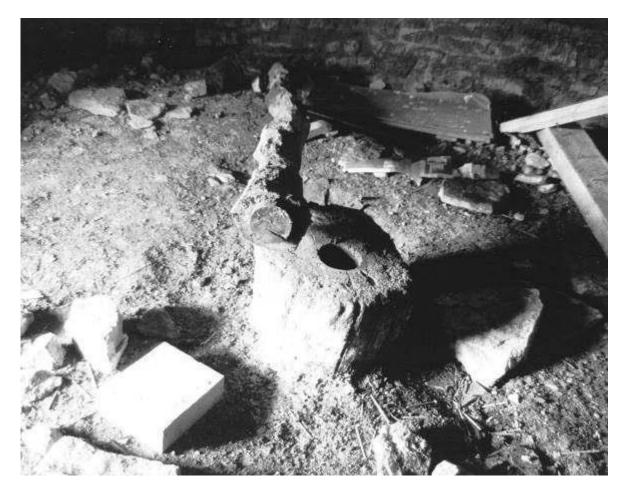
Before recent work by the tenant farmer there was a vertical timber set into the base. This was 2410mm long, 190 x 140mm at the base with a circular tenon 100mm diameter and 40-42mm deep. This was heavily wood worm infested and had a rough tin collar near the top. There was no indication of any mortises to take the braced arms holding a ladder. It is likely that this timber was part of a roosting frame erected during the period the dovecote housed chickens.

14 Central timber block and detached post
